### **FALCON MEWS PROJECT 05-0205**

# **Environmental Assessment**

**Falcon Mews**

**Project No. 05-0205**

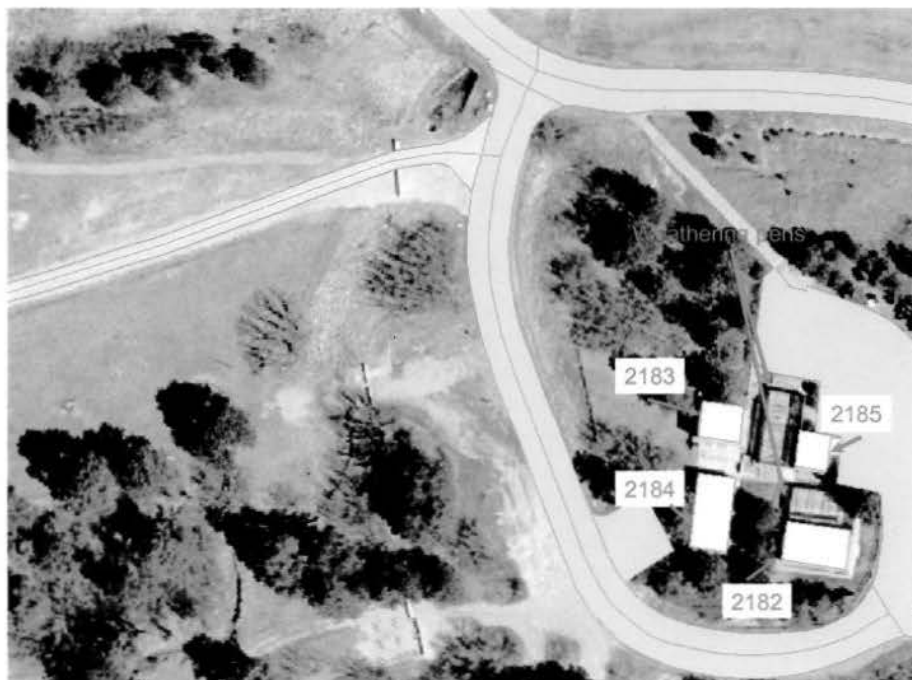
Figure 2 Location close-up of falcon mews showing position of existing buildings and weathering pens.

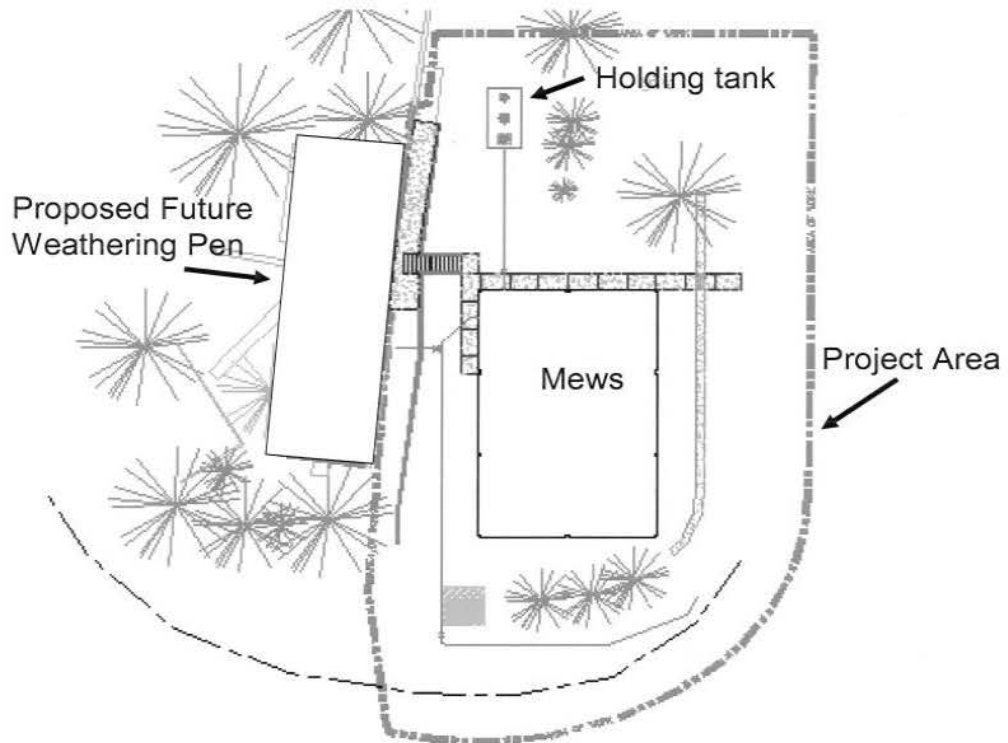
Figure 3 Proposed Action including new mews and future weathering pen

The proposed action will replace two existing buildings that support the falconry program, 2182 and 2185, and replace them with a single building placed within the footprint of the older buildings (Figure 3). The existing weathering pen will be removed. The remaining buildings, 2183 and 2184, will be removed during a separate action that is not yet funded and a new 1,300 square-foot weathering /flight pen, an open-air enclosure where birds may be placed outdoors, will be constructed within the footprint of the buildings to be demolished. (Figure 3).

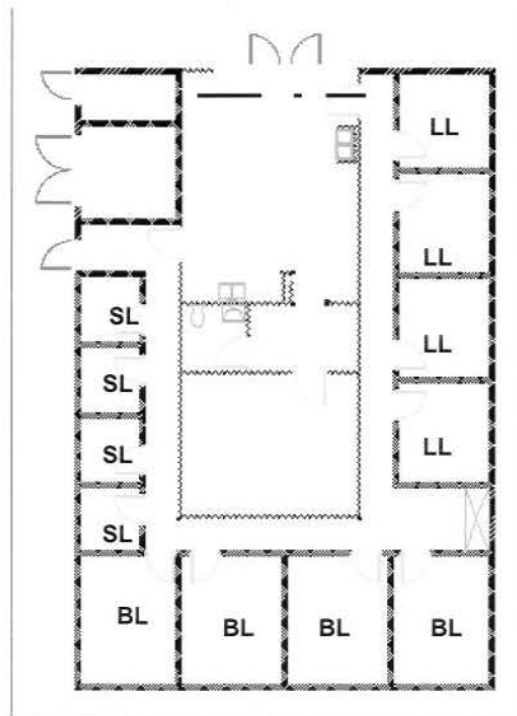
The new facility will incorporate four large lofts (10 feet 6 inches by 10 feet 6 inches), four small lofts (7 feet by 7 feet), four breeding lofts (three at 10 feet 6 inches by 13 feet 6 inches and one at 9 feet 11 inches by 13 feet 6 inches), a workroom, two storage rooms and a restroom and locker room. Utilities will hook into existing lines. A sanitary holding tank will serve both the restrooms and the waste generated by washing the lofts. Interior plans are shown in Figure 4.

Figure 4 Interior plans for new falcon mews. LL: large loft, SL: small loft, BL: breeding loft.

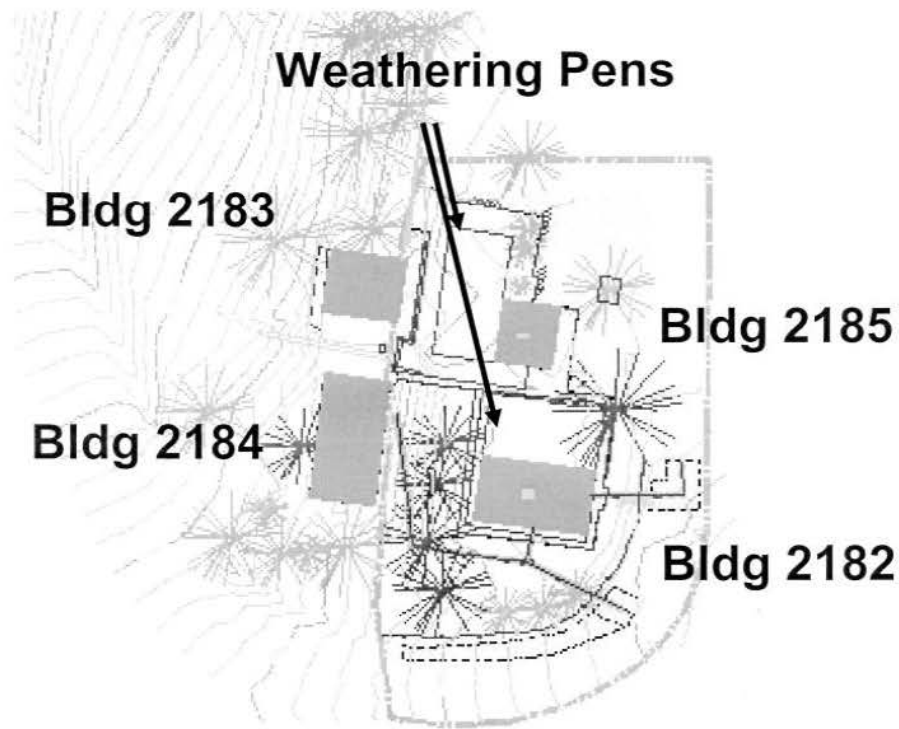
The Falcon Mews incorporates a cluster of four buildings (2182, 2183, 2184 and 2185). Bldg. 2182 (720 square feet) was built in 1966 as pre-engineered metal building, as was building 2183 (800 square feet) constructed in 1974. Buildings 2184 and 2185, (473 and 476 square feet, respectively) were constructed in 1988 of precast panels with exposed aggregate finish. Figure 5 shows the layout of the existing buildings.

Figure 5 Existing Falcon Mews consisting of four buildings and two weathering pens.

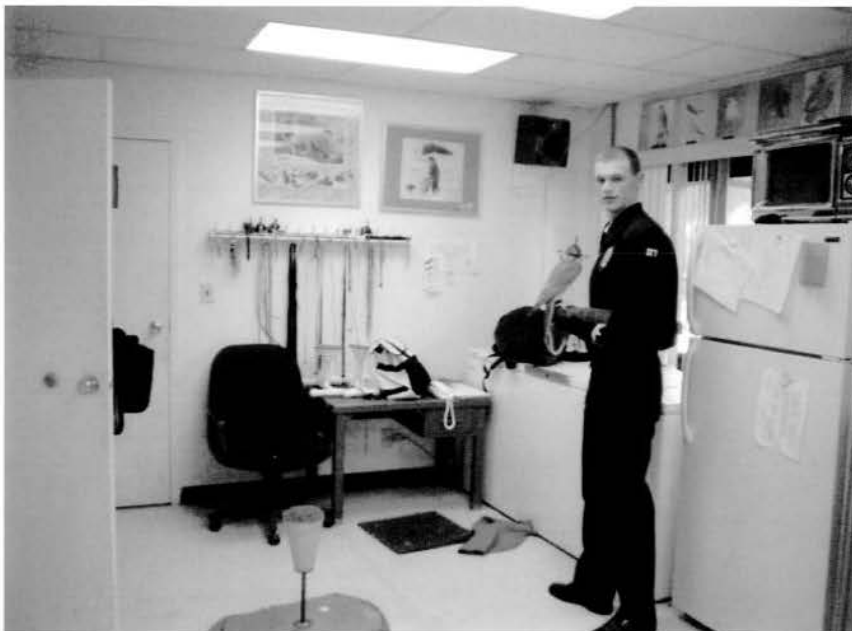
The existing workrooms and lofts (Figures 6 to 8) are poorly illuminated. The interior walls are made of gypsum sheet rock. Birds defecate on the walls and floors. Because the walls are made of sheet rock and wood, they cannot be easily cleaned. Moisture trapped in the walls encourages mold growth.

Figure 6 Primary work area, Building 2182.

Buildings 2182 and 2185 were constructed in 1966 and buildings 2183 and 2184 in 1988. The current preparation and handling facility, Building 2182, is in poor repair. Linoleum is coming apart. The facility is poorly lit and difficult to clean. The combination of aging structure and poor illumination increase safety risks for cadets, supervisors, and visitors (Figure 6).

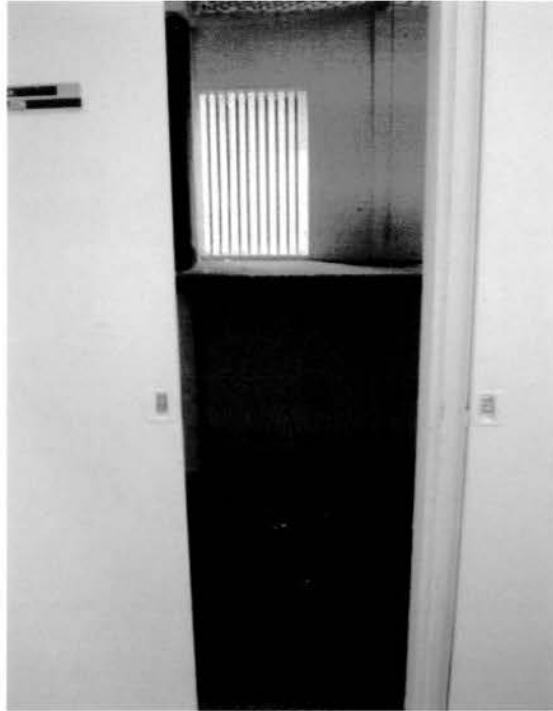
**Figure 7** Entrance to a falconry loft. Lofts are poorly lit and are too narrow for birds to effectively exercise limbs.

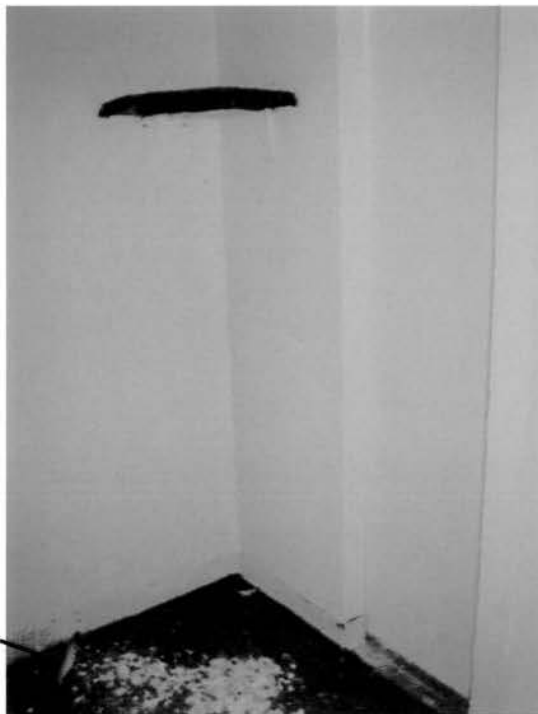
**Figure 8** Interior view of falconry loft. Fecal material accumulates below perches. Sanitizing existing lofts is difficult.

Molds can affect the health and well-being of the birds. Baseline laboratory results show antibodies for mold, which indicates the birds have been exposed to mold. In a natural environment, falcons would be unlikely have these antibodies because the open environment in which they live would not expose them to molds.
